BUILDING SURVEY

Client Name	Claire Smith
Property Address	10 Tennis St Racquet Town
Date of Inspection	5 May 2023

Chawton Hill Associates Ltd	Wesley House Bull Hill Leatherhead Surrey KT22 7AH
Originated	Joe Clark Assoc(RICS)
Reviewed	Director
Date	01 January 2023

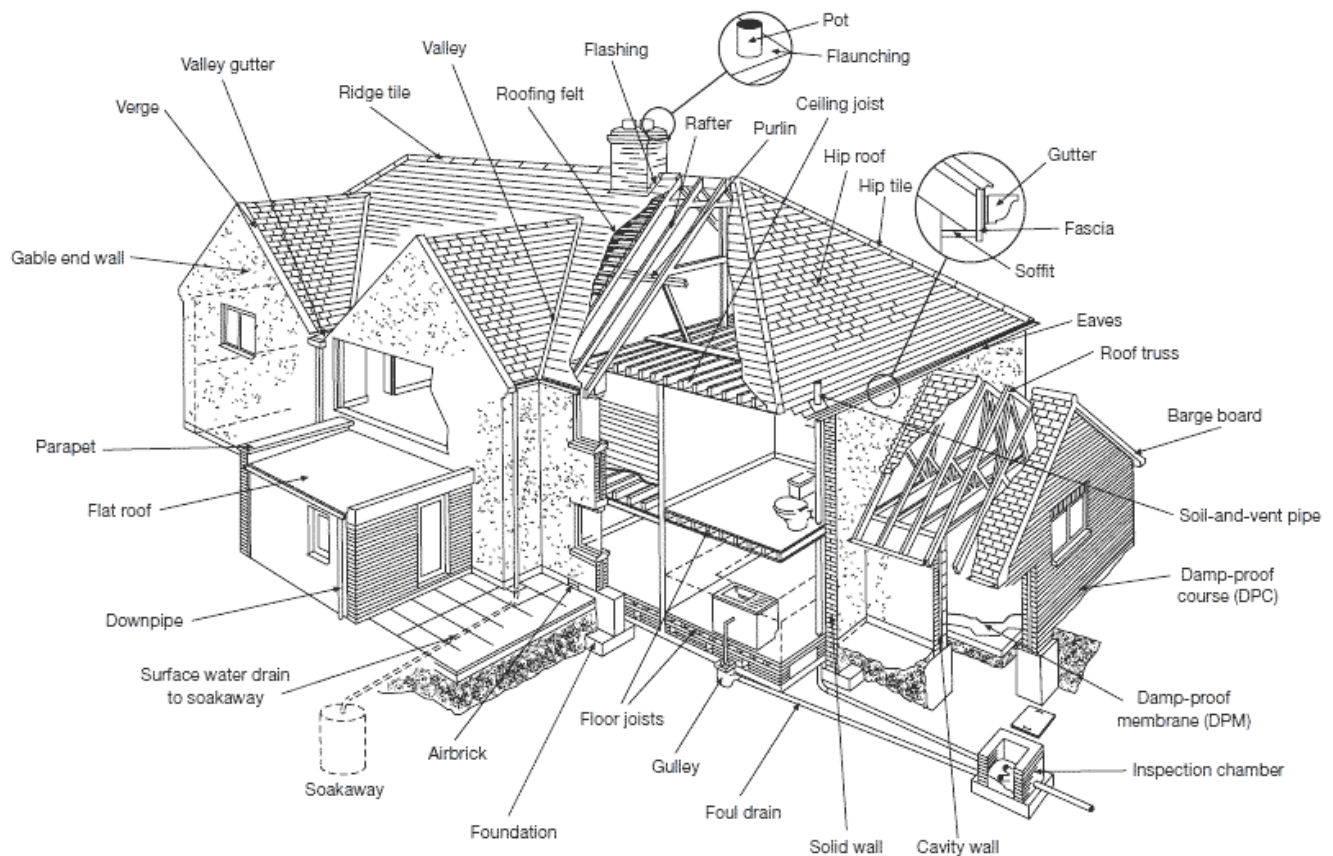
10.0 Typical House Diagram

A guide to some of the building elements described in this report.
